DrySafer™

DRYER VENT ALARM

Detects Dangerous Lint Buildup Before it Causes Damage.

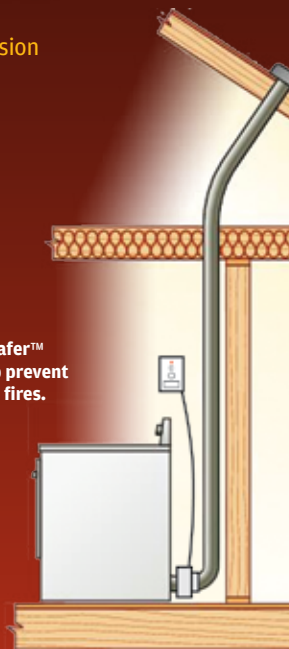
Clogged dryer vent ducts can cause dryer fires.

Bird nests are a major cause of vent blockages.

As lint builds up inside a dryer or the dryer’s exhaust vent, a blockage can result in insufficient airflow, causing the dryer to overheat. This can ignite the lint and cause a fire.

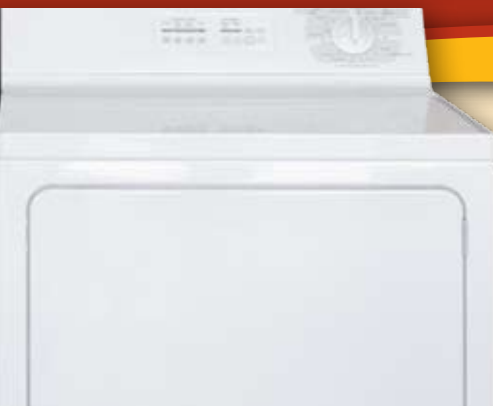
7 Full Size Bath Towels	Test Results from independent study:*			
	Drying Time	Kilo Watts Used	Cost Per KW	Total Energy Used
Normal Conditions:	55 Minutes	2.6	0.14	\$0.36
Vent 62.5% Clogged:	88 Minutes	4.6	0.14	\$0.64
Total Savings Per Load:	33 Minutes	2.0	0.14	\$0.28

A dryer with a load of 7 large bath towels and vent restriction of 62.5% took 60% more time to dry the same size load and used 77% more energy than the load without the restricted vent pipe.

- Testing equipment included use of 12 feet of 4-inch aluminum vent pipe
- Testing procedure conducted 3 times with identical loads to arrive at weighted average for findings
- Kilo Watt rates based on: JCP&L Utility Co. rates (NJ)
KWH = 0.092677
Delivery Charge = 0.046847
